## Case Study River Bain, Donington on Bain

**Chalk Streams**  
of Lincolnshire

Donington on Bain, Lincolnshire.

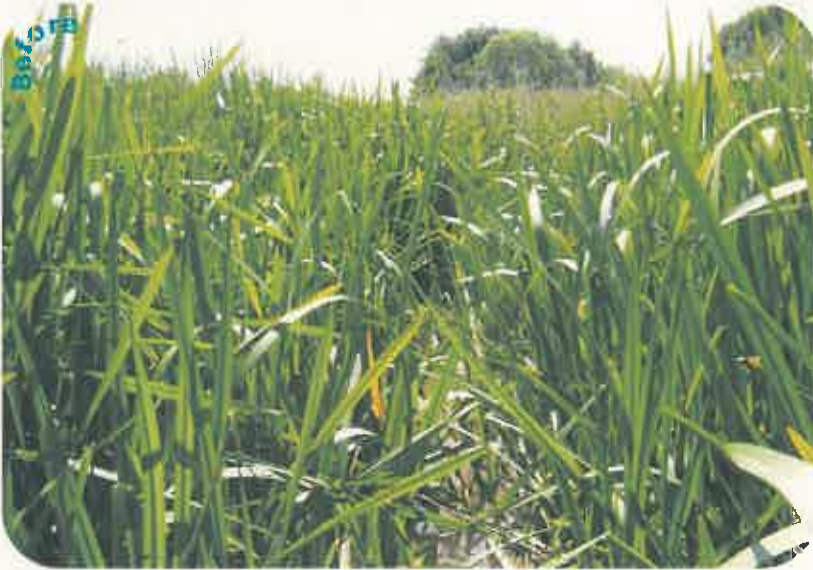
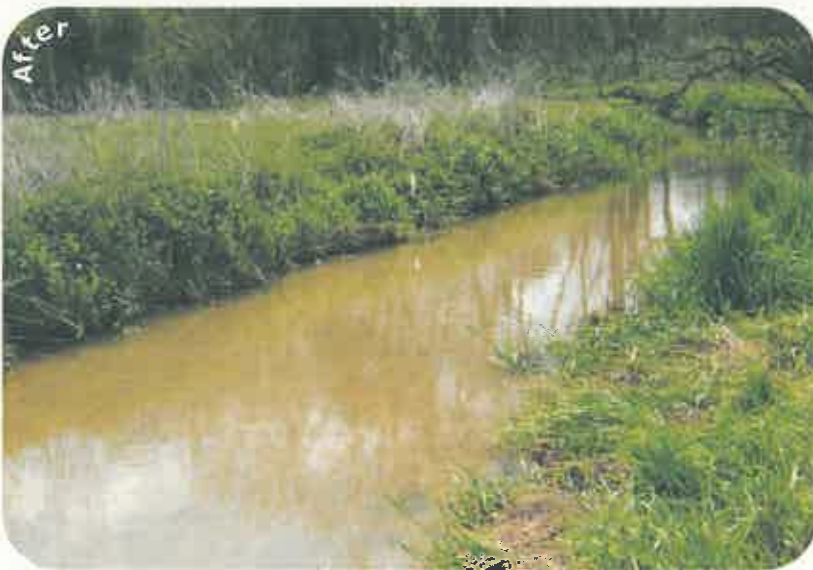
*"The River Bain at this point was clogged with sediment. The new riffles have raised the bed, providing much needed habitat for the struggling trout population."*

A section of the River Bain between two impassable weirs has resulted in a loss of habitat for trout; significant amounts of sediment have smothered the bed and marginal vegetation is encroaching to block the channel.

- Two gravel riffles created to enhance spawning opportunities for trout.

- An increase in water velocity will scour the new bed, ensuring sediment does not smother the gravel. This will allow trout spawning to occur as well as provide variable habitat for the differing life stages of the trout.
