Case Study Burwell Beck, Swaby

Chalk Streams
of Lincolnshire

Project location:
Swaby, Lincolnshire.

Date:
February 2011

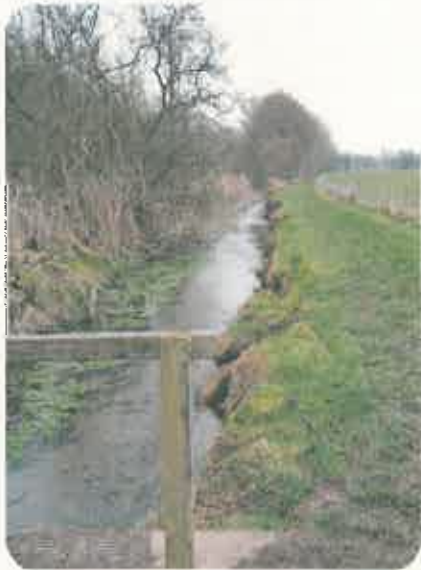
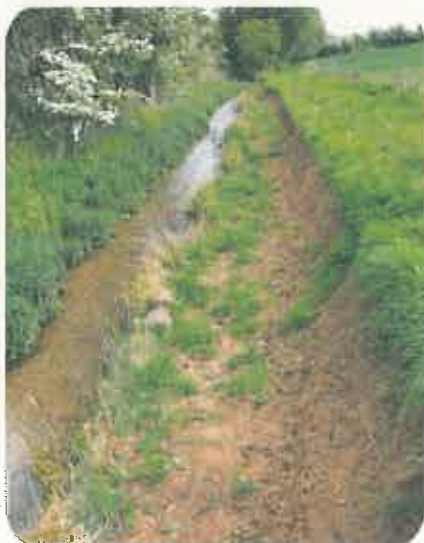
An 80m stretch of bank on the Burwell Beck was collapsing into the channel. This was contributing to sediment building up in the watercourse.

- Re-graded bank.
- Pre planted coir roll used to revet the bank and replace water vole habitat.

- Bank stabilisation.
- A more naturalised bank profile with a 2 stage bank to cope with elevated water levels.
- Reduced sediment mobilisation in the channel resulting in cleaner gravels.
- Improved habitat for fish and invertebrates.
